October 2021

Comparative Out-of-Box Photo Reliability Test: Canon PIXMA G650 vs. Rival Ink Tank Device

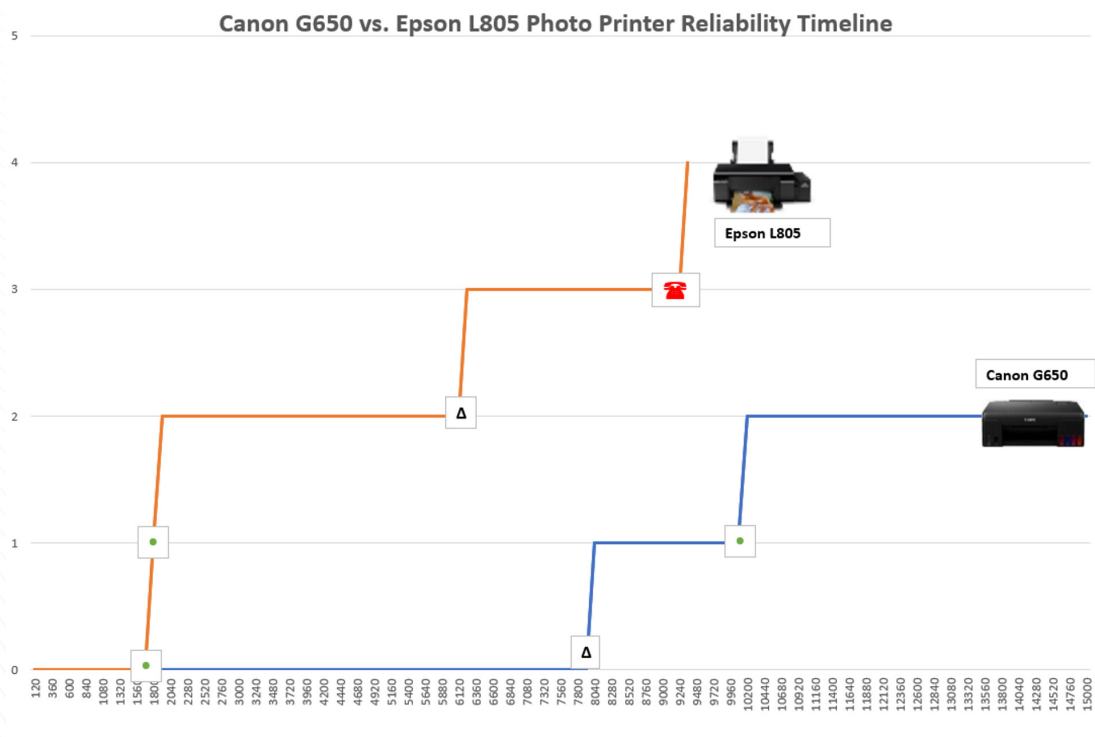
This chart tracks the incidence of image defects for each device and shows the point at which a device stopped testing. The green circle icons denote the points at which an ink ejection defect occurred but subsequently resolved itself before the end of the batch. The triangle icons denote the points at which an ink ejection defect occurred that required a head clean to resolve the issue.

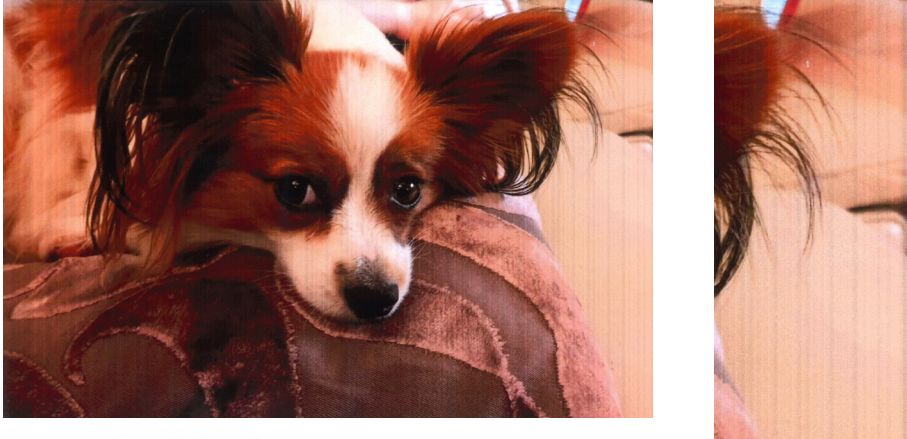
Canon PIXMA G650 Batch 67

Banding was noticeable in this photo, as can be more clearly seen in the zoomed-in version on the right. The issue required a printhead clean to resolve it.

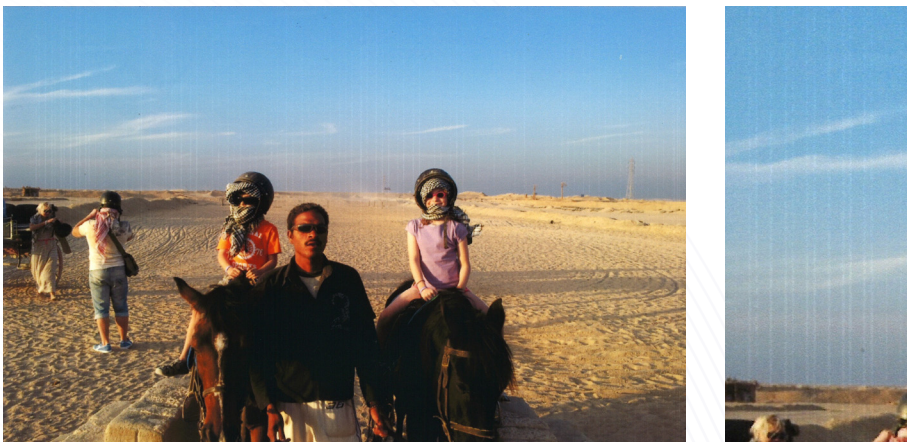
Canon PIXMA G650 Batch 85

Banding was noticeable in this photo, as can be more clearly seen in the zoomed-in version on the right. The issue resolved itself without any user intervention.

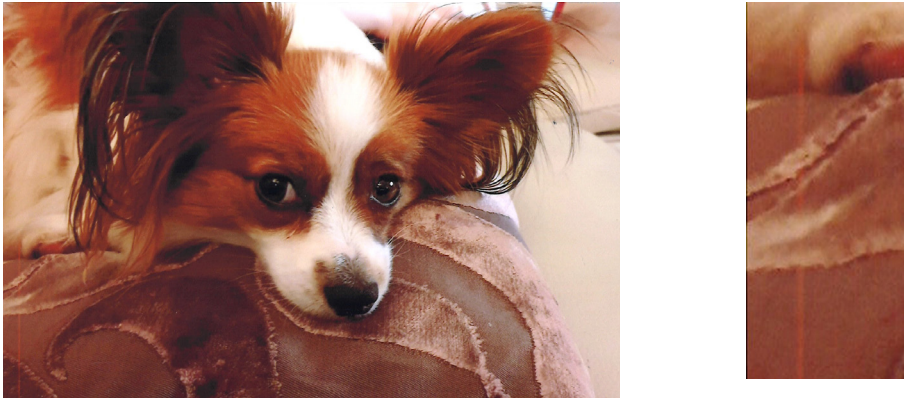
Device A Batch 15

A vertical band appeared on the left, as can be more clearly seen in the zoomed-in version on the right. This was due to a nozzle blockage, but the issue resolved itself without any user intervention.

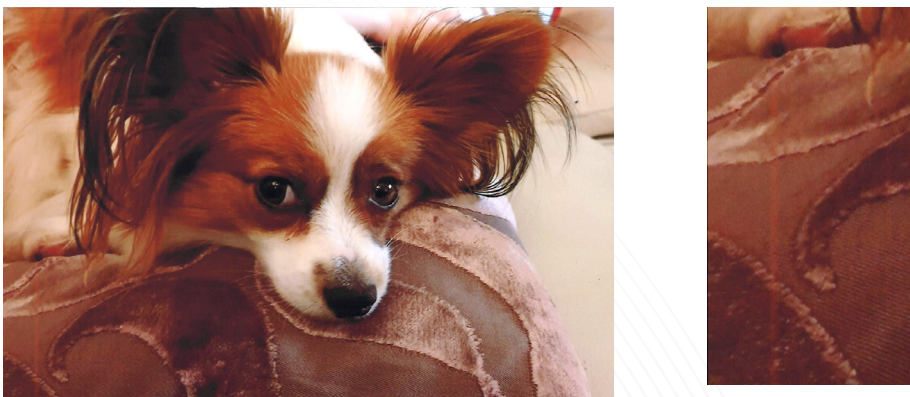
Device A Batch 16

A vertical band appeared on the left, as can be more clearly seen in the zoomed-in version on the right. This was due to a nozzle blockage, but the issue resolved itself without any user intervention.

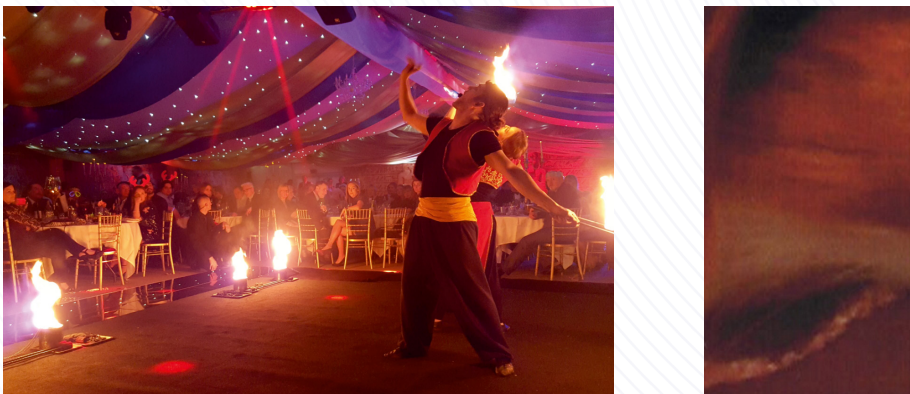
Device A Batch 52

Banding due to an ink ejection failure was noticeable in this photo, as can be more clearly seen in the zoomed-in version on the right. The issue required a printhead clean to resolve it.

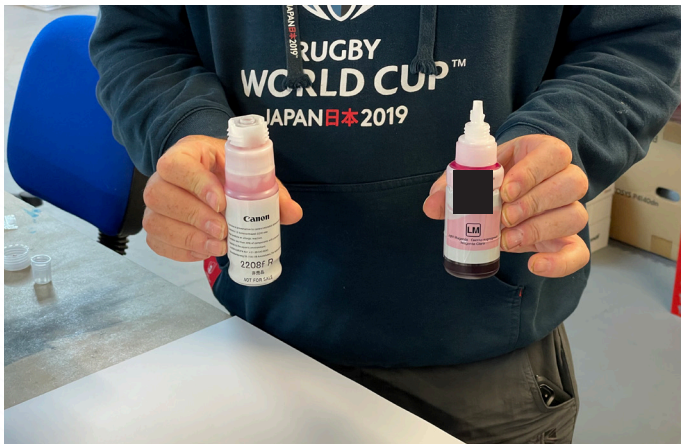
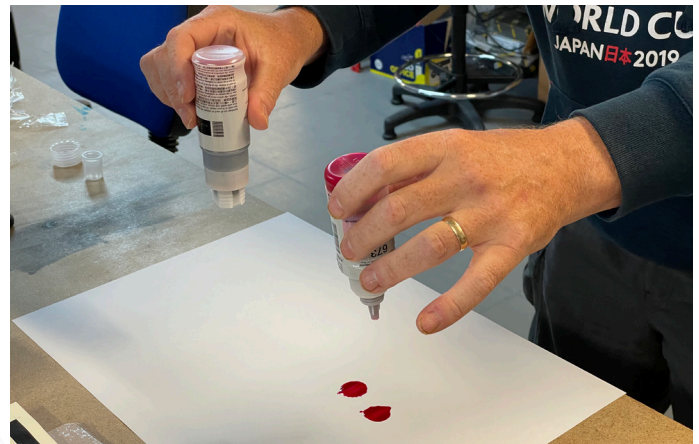
The Canon PIXMA G650 bottles are keyed so they can only fit in the correct ink tank, and no ink can come out of the bottle unless it is inserted in an ink tank. In contrast, Device A's bottles are not keyed and can be placed in any ink tank, so the user refilling ink tanks must be careful to put ink in the correct tank. Device A's ink bottles release ink even if they aren't inserted in an ink tank, which meant that refilling Device A's ink tanks was a messy affair. The image on the right below shows a lab technician holding the Canon and Device A ink bottles upside down, and it can be seen that the Canon bottle does not leak ink while the Device A one does.

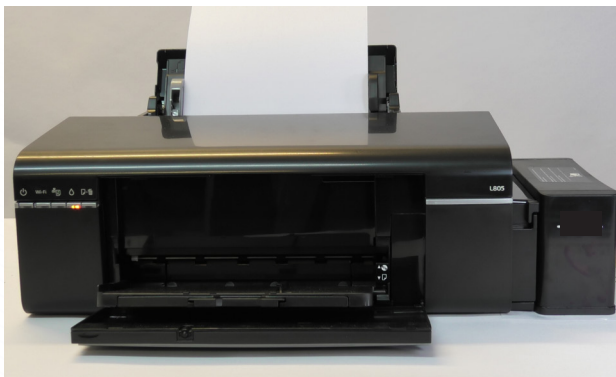
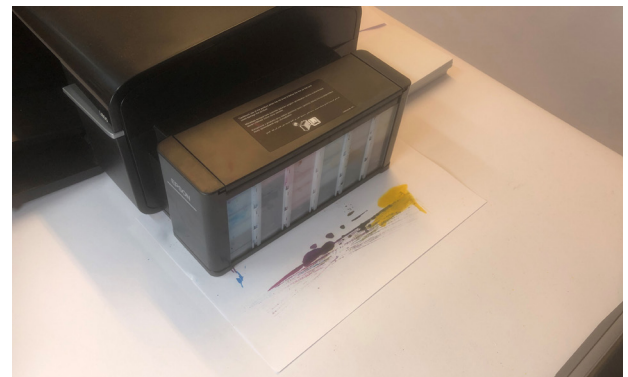
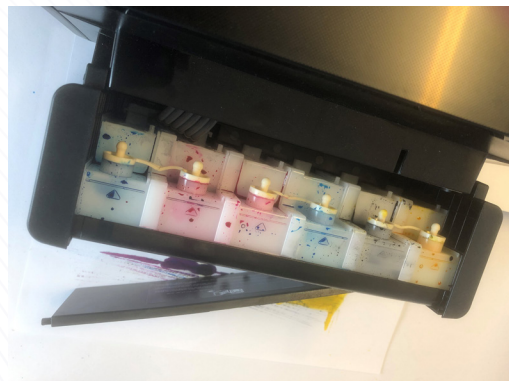
The position of the ink tanks in a device has a direct bearing on the ease of use and accessibility of the device. A poorly placed ink tank will prevent users from accurately seeing the remaining capacity of the ink tanks, refilling the ink tanks easily and placing the device in a more convenient spot. Device A's ink tank is located on the right side of the device, which means users won't be able to see the remaining ink capacity easily unless they view the device from the right side, and it could prevent users from placing the device in a more convenient location because they'll have to leave space in which they can refill the tanks. The tanks are not colour-coded, which means users will have to be careful to put ink in the correct tanks. Users must open the tank bay and then pull the tanks down to put them in the correct position for refill, which means more room is needed than Device A's normal footprint. The images below show Device A with its ink tank bay opened and closed.
