DECEMBER 2019

## Canon PIXMA G4511 versus Device A and Device B Reliability Test

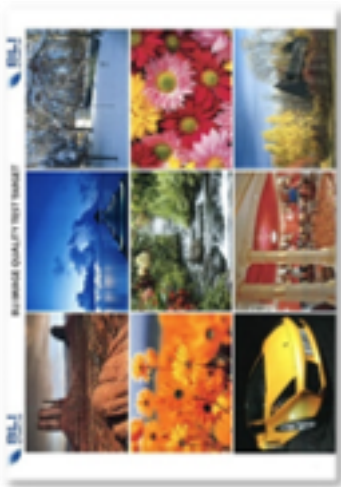
3 Rating: Smooth tones, vibrant colours, with fine detailing and good contrast

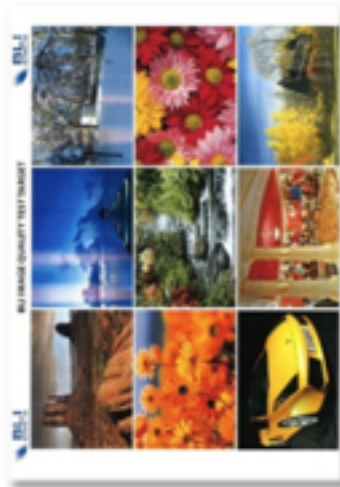
2 Rating: Some localized defects, but overall quality is okay

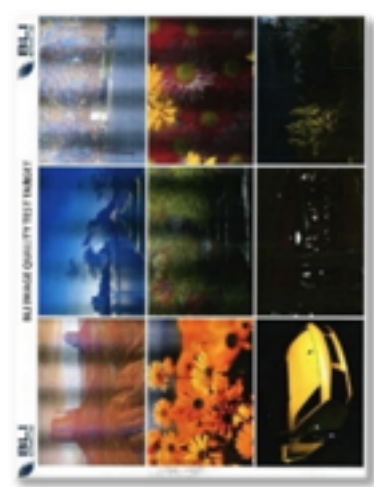
1 Rating: The whole page suffers from poor quality, rendering it unusable

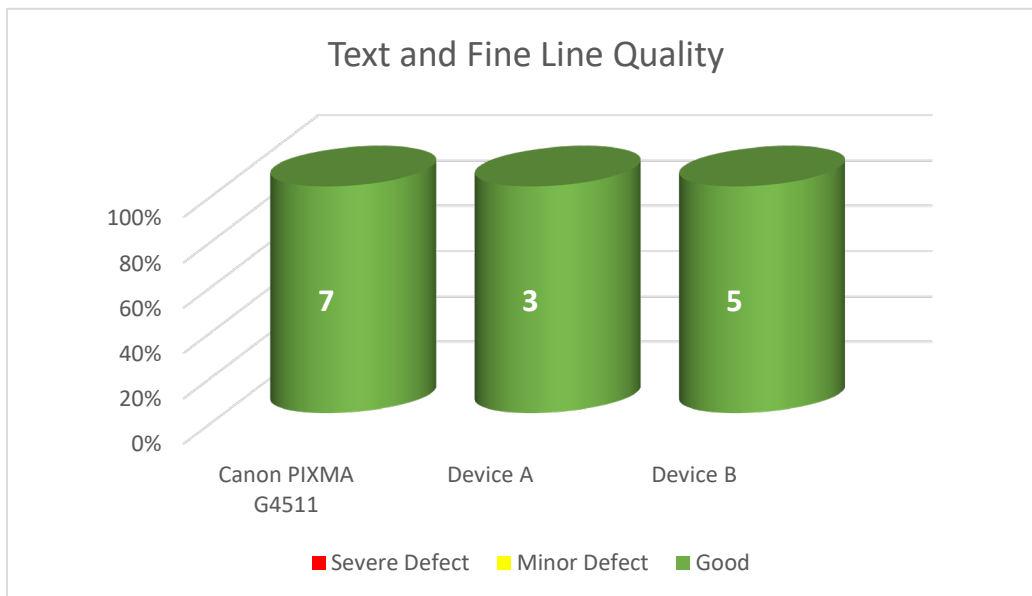
Grades for text and fine lines are indicated by a colour, such as green, which means there were no defects; yellow, which represents a minor defect; and red, which represents a severe defect. The number on the cylinders relates to the number of image quality samples produced.

Throughout testing, all three devices produced samples that displayed consistent image quality, with photographs, text, and fine lines that earned a 3 rating.

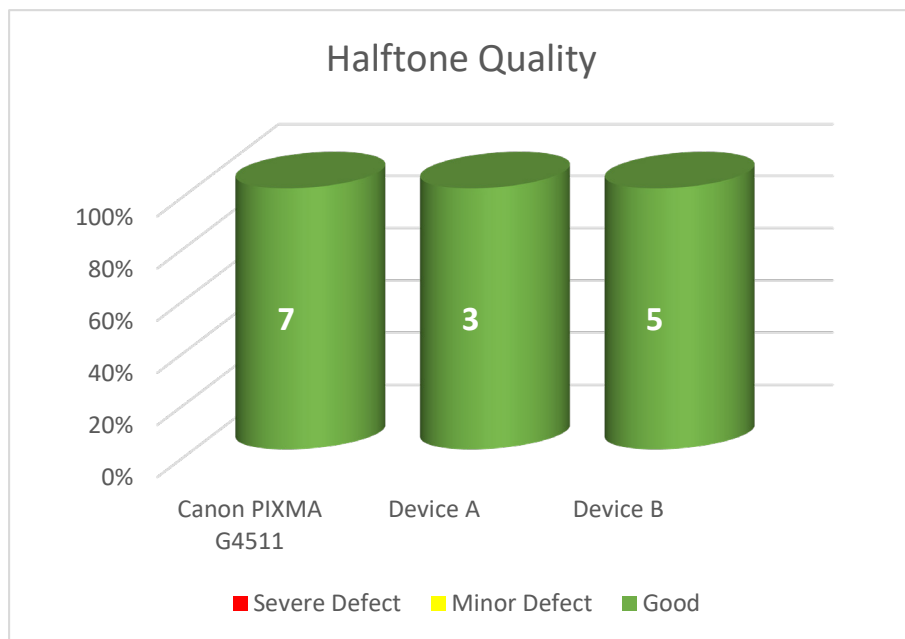
Grades for text and fine lines are indicated by a colour, such as green, which means there were no defects; yellow, which represents a minor defect; and red, which represents a severe defect. The number on the cylinders relates to the number of image quality samples produced.

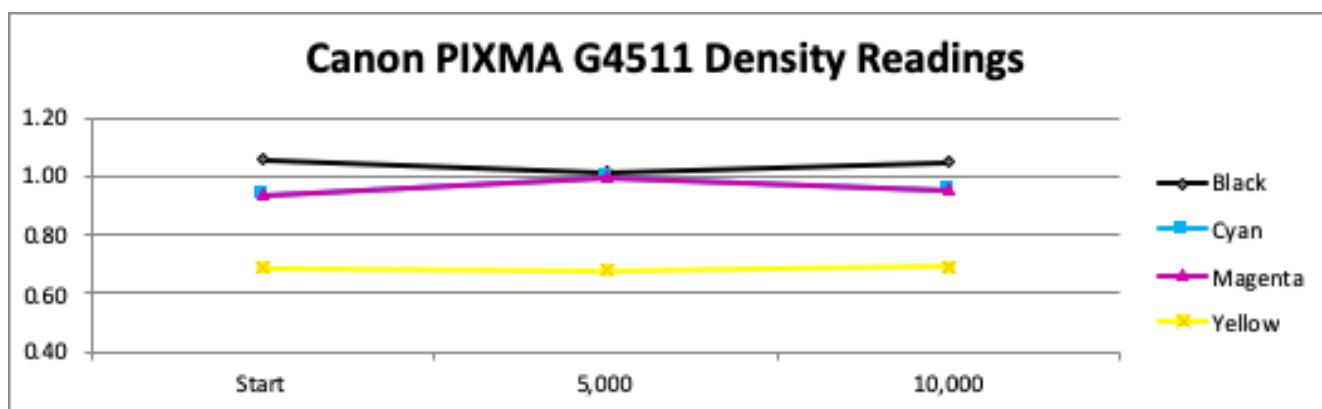
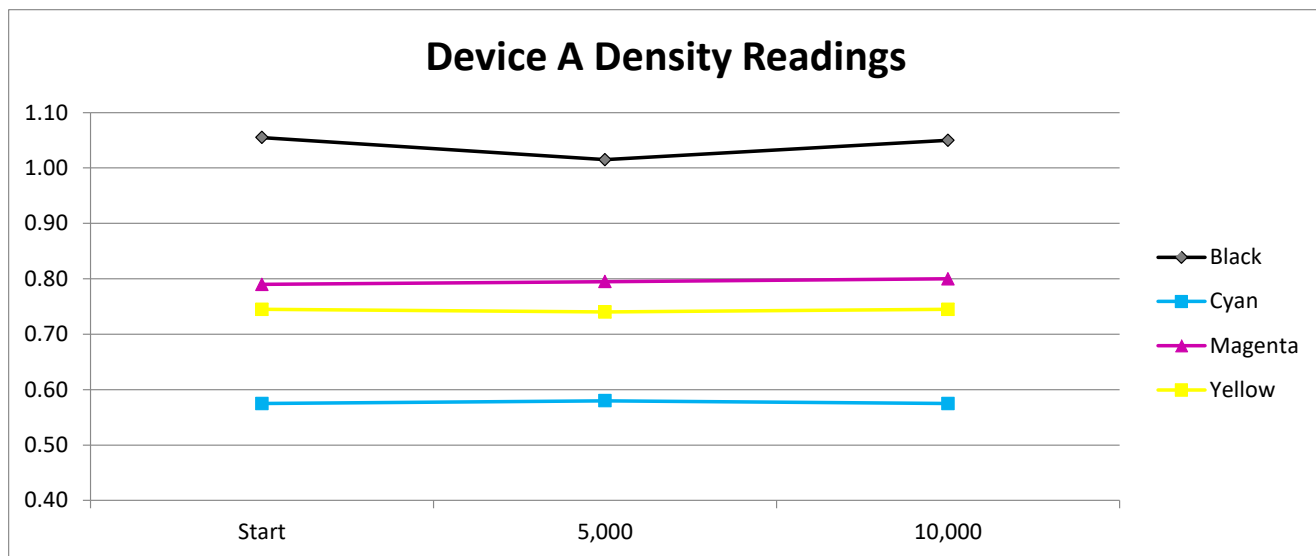
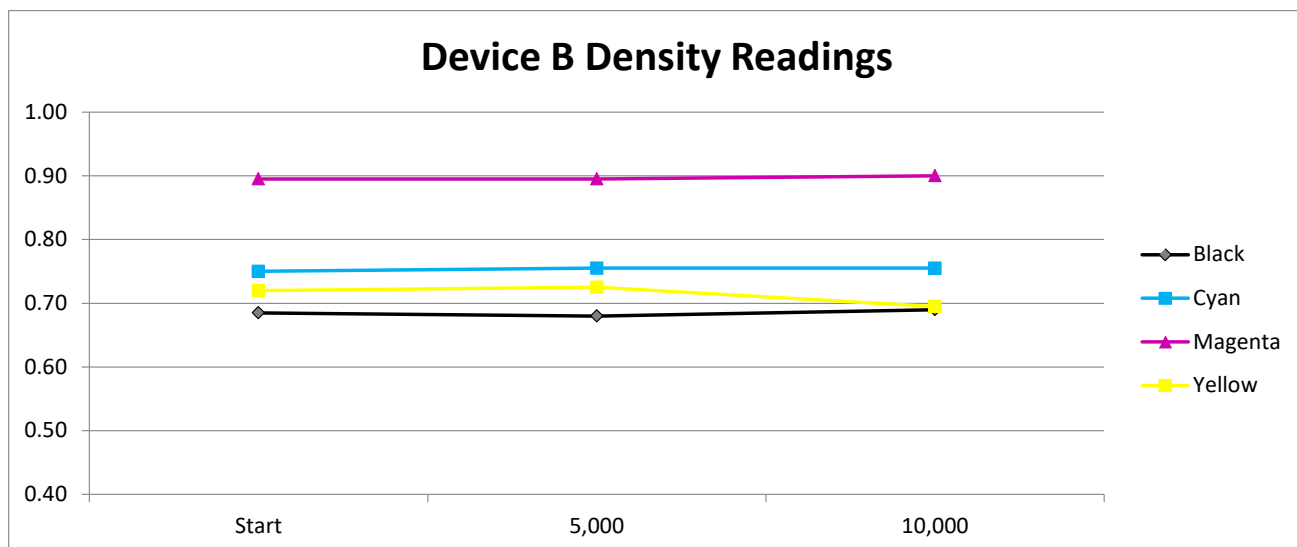
Device A and Device B both had very consistent density readings, with the Canon PIXMA G4511 not far behind. However, the real-world differences between the readings are negligible.

As Device A only printed 11,356 impressions, Buyers Lab could compare only the first three density readings from the devices.

Canon PIXMA G4511				
	Average	Maximum	Minimum	Variance
Black	1.04	1.06	1.02	0.04
Cyan	0.96	1.00	0.94	0.06
Magenta	0.96	1.00	0.94	0.06
Yellow	0.69	0.69	0.68	0.01
Device A				
	Average	Maximum	Minimum	Variance
Black	1.04	1.06	1.02	0.04
Cyan	0.58	0.58	0.58	0.01
Magenta	0.80	0.80	0.79	0.01
Yellow	0.74	0.75	0.74	0.01
Device B				
	Average	Maximum	Minimum	Variance
Black	0.69	0.69	0.68	0.01
Cyan	0.75	0.76	0.75	0.01
Magenta	0.90	0.90	0.90	0.01
Yellow	0.71	0.73	0.70	0.03

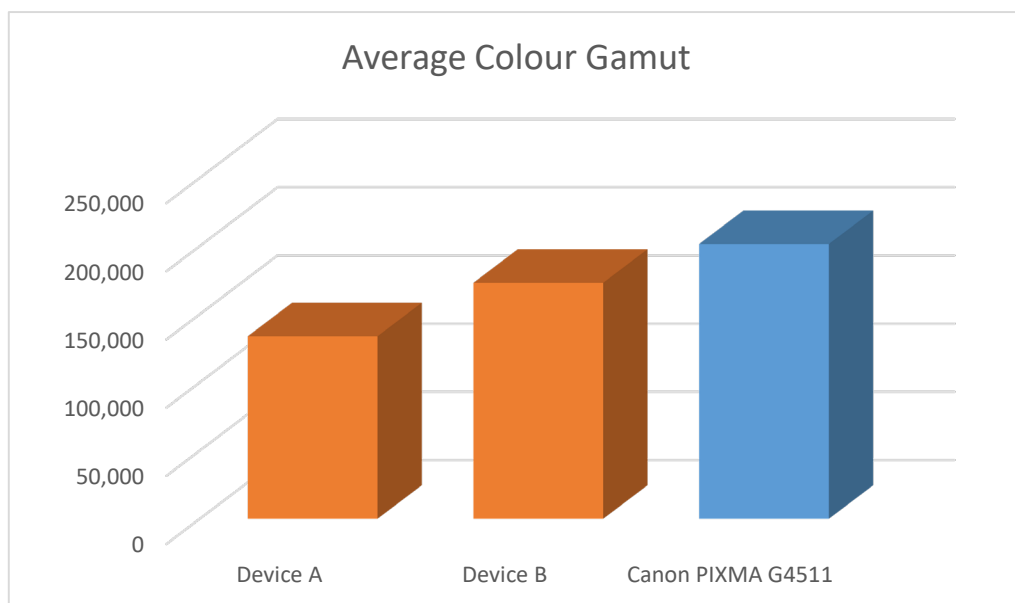
Colour gamut represents the ability to render a range of colours, with a larger gamut indicating the ability to produce a wider range of shades and hues. Even though the difference between its lowest and highest colour gamut readings was higher than its rivals, the Canon PIXMA G4511's average CIE colour gamut was much higher than Device A and Device B's. Indeed, the Canon G4511's average colour gamut is 50.5% higher than that of Device A, and 16.4% higher than that of Device B.

Max and Min indicate the highest and lowest volumes over the course of testing.

CIE Colour Gamut Volume				
	Average Volume	Min Volume	Max Volume	Variance
Canon PIXMA G4511	201,536	197,657	206,940	9,283
Device A	133,870	128,236	136,888	8,652
Device B	173,108	168,428	176,765	8,337
