## Canon PIXMA GM2050 versus Device A Reliability Test

### Test Objective

Keypoint Intelligence - Buyers Lab was commissioned by Canon Europe Ltd. to conduct a 30,000-impression reliability test on the Canon PIXMA GM2050 and Device A. Testing took place over a period of 20 days, and involved printing the ISO 24734 test suite and a batch of proprietary Buyers Lab image quality files. Image quality was checked every 5,000 impressions to assess the consistency of output. The printers were operated in default mode, with any misfeeds, multi-sheet feeding, misalignment skewing, and printer malfunctions, or failures recorded. All testing was conducted at Buyers Lab's European test facility. The Canon PIXMA G2050 is also sold as the Canon PIXMA G2040, so this report is also applicable to that device.

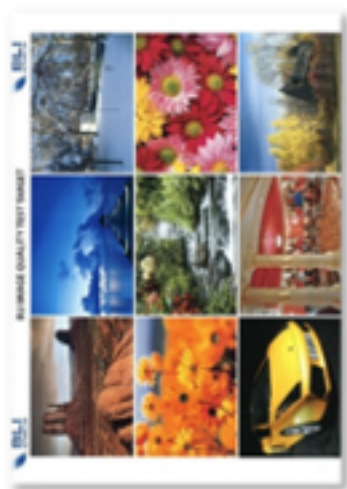
3 Rating: Smooth tones, vibrant colours, with fine detailing and good contrast

To assess the print image quality consistency of the Canon PIXMA GM2050 and Device A, Buyers Lab's proprietary image quality test targets were printed on each device, with samples taken at 5,000-impression intervals. Image quality was assessed in several areas, such as text and fine lines, as well as solid density and colour gamut volume. The sample pages were compared and graded on a three-point scale where 3 is excellent, 2 is good, and 1 is poor. From a user perspective, output with a 3 rating would be nearly flawless, meeting the higher standard required for distribution to external clients; a 2 rating would be average, and while showing some slight defects or flaws would be suitable for internal use; lastly, a 1 rating would have major defects and could be illegible in places rendering it unusable. The aim of the test in this context is not to provide in-depth comparative analysis on the image quality of each device, but to ascertain the consistency of the device's output over the duration of the test, and to note any reduction in quality from the start of the test.

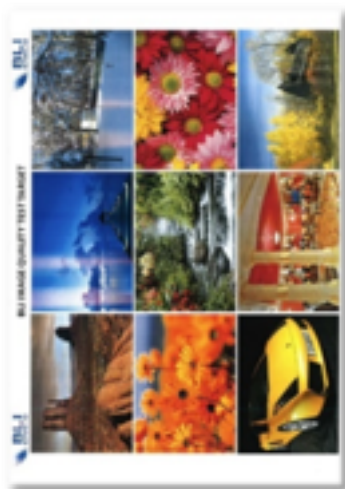
2 Rating: Some localized defects, but overall quality is okay

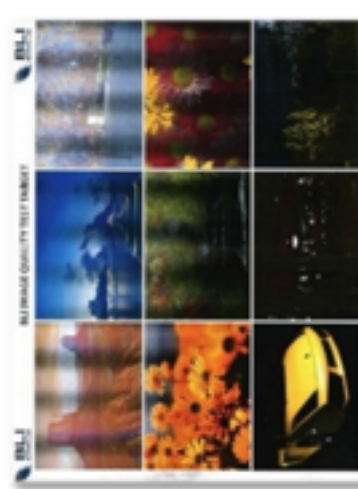
1 Rating: The whole page suffers from poor quality, rendering it unusable

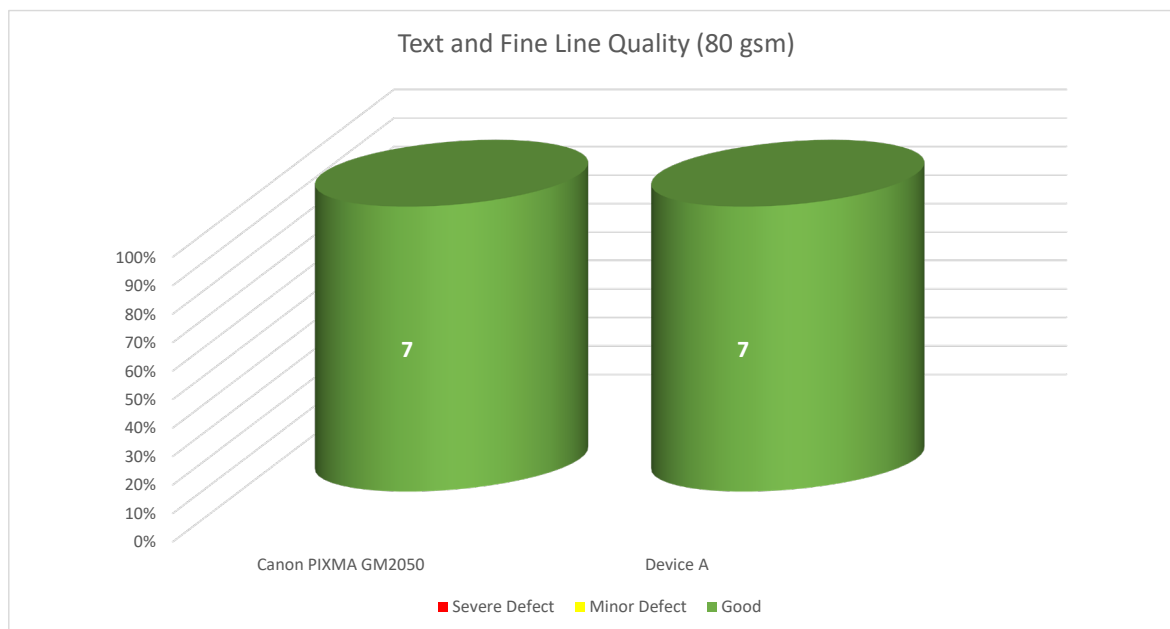
Grades for text and fine lines are indicated by a colour, such as green, which means there were no defects; yellow, which represents a minor defect; and red, which represents a severe defect. The number on the cylinders relates to the number of image quality samples produced.

In Buyers Lab's testing, both devices produced image quality samples that were consistent over the course of the test, with neither device producing image quality samples that were unexpectedly sub-par.

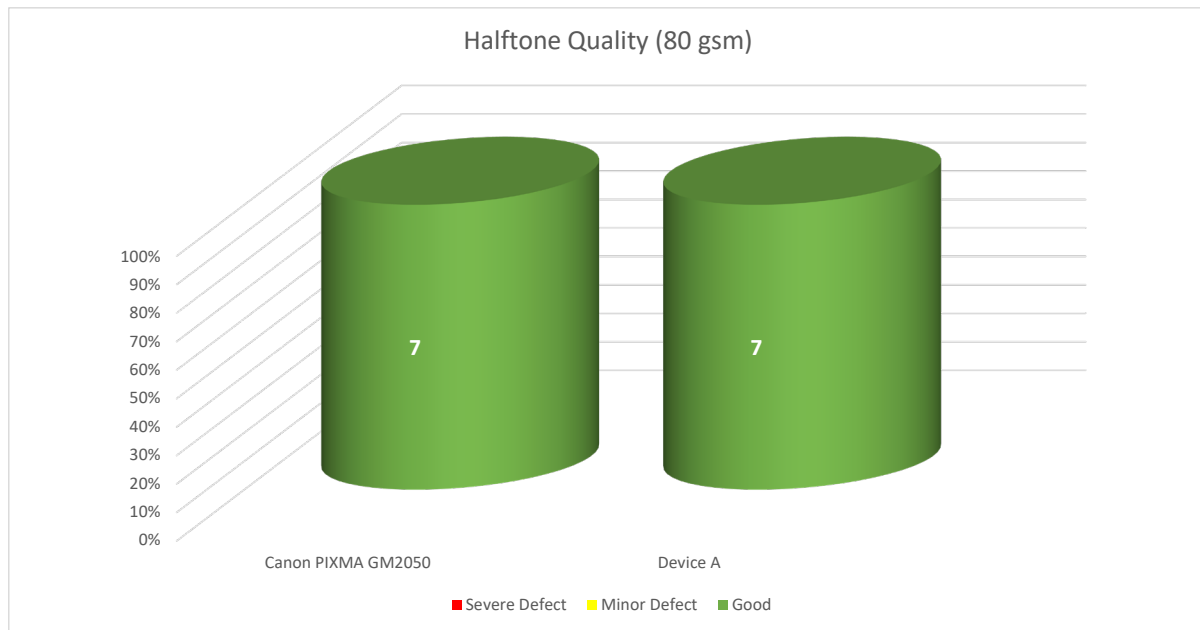
Grades for halftones are indicated by a colour, such as green, which means there were no defects; yellow, which represents a minor defect; and red, which represents a severe defect. The number on the cylinders relates to the number of image quality samples produced.

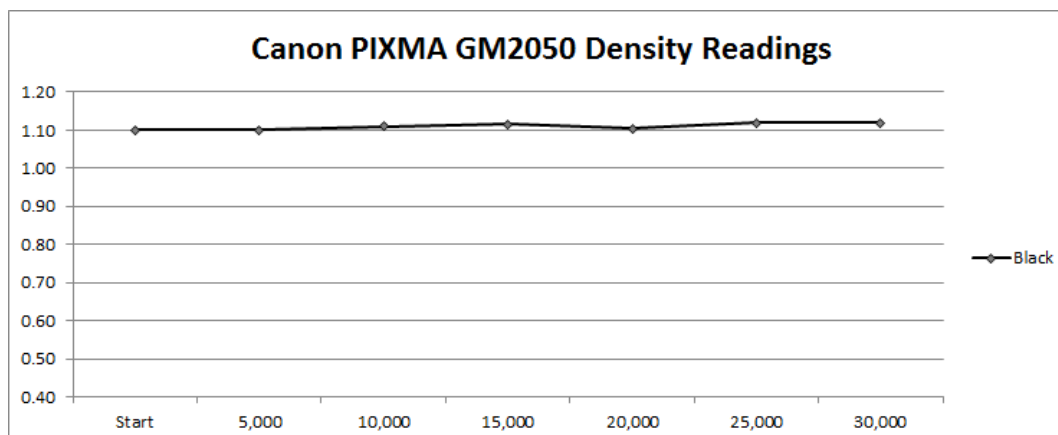
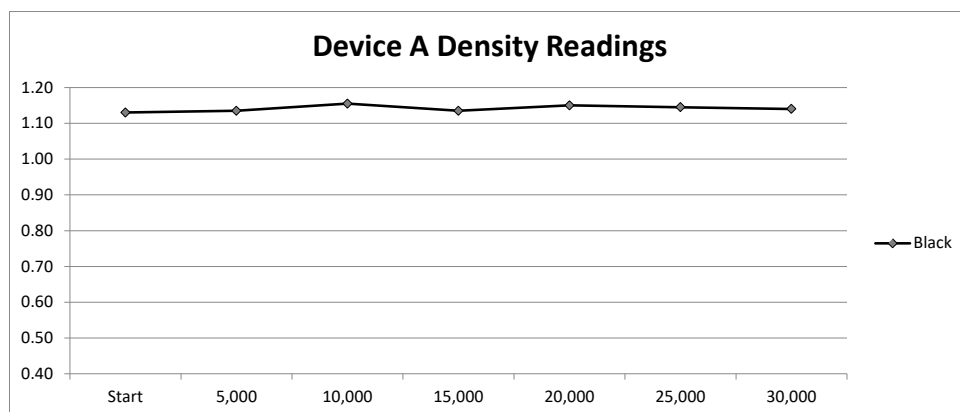
## Density

A higher print density reading for black means that output will be darker and/or richer. The Canon GM2050 and Device A both produced consistent density readings throughout testing, with only a variation of 0.02 between each device's lowest reading and its highest reading.
